Manhole Inspection Summary

Manhole # **S17G__036MH**

Insp Date: **9/21/09 9:55 AM**

Location Address: **2431 N WARWICK AV**

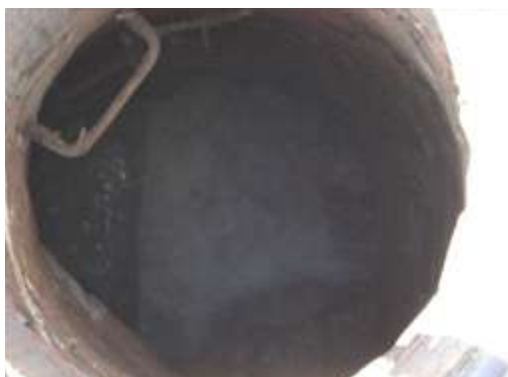
Defect 2

☒ **Evidence Of Surcharge** Depth: **4** (ft.) ☐ Active Surcharge Present

evidence of ASUR

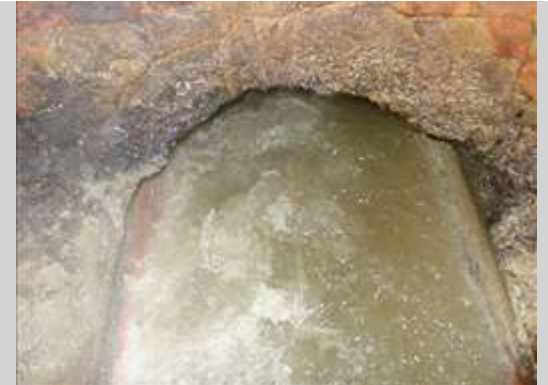
12 O'Clock Outflow

27 in. Circular Gravity Sewer
Pipe Out @ 12 O'Clock

Pipe Height: (in.) Direct
Pipe Material: **Concrete** ☐ Pipe Lined
Invert Depth: **10.69** (ft.) Flow Characteristics: **Fast**
Deposits: ☒ None ☐ Mud ☐ Sludge ☐ Debris ☐ Grease
Silt Depth: (in.) Deposits Extent:
Infiltration: **None** Pipe Seal Cond: **Sound**

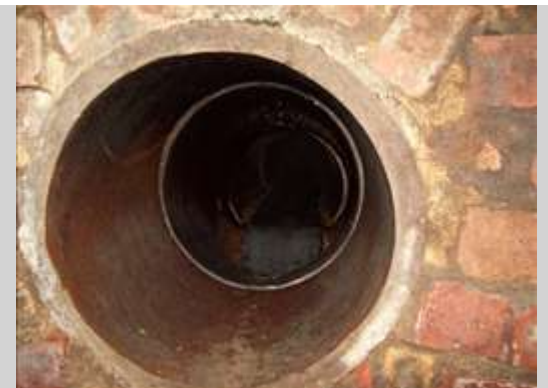
3 O'Clock Inflow

12 in. Circular Gravity Sewer
Pipe In @ 3 O'Clock

Drop In @ 3 O'Clock

Pipe Height: (in.) Direct
Pipe Material: **Clay** ☐ Pipe Lined
Invert Depth: **7.20** (ft.) Flow Characteristics: **Fast**
Deposits: ☒ None ☐ Mud ☐ Sludge ☐ Debris ☐ Grease
Silt Depth: (in.) Deposits Extent:
Infiltration: **None** Pipe Seal Cond: **Sound**

Drop: **Inside** **Direct**
Angled: Reading: (ft.)
Inv Depth: **9.22** (ft.)

Drop Condition: **Open**

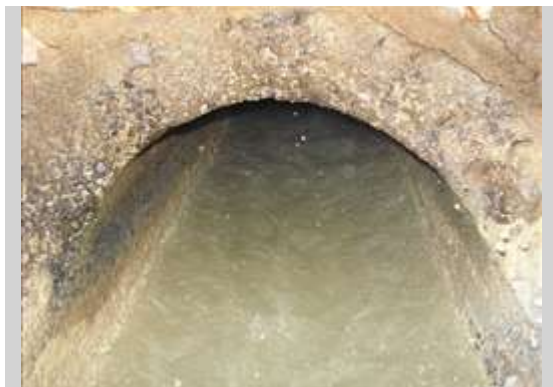
6 O'Clock Inflow

27 in. Circular Gravity Sewer
Pipe In @ 6 O'Clock

Infiltration: **None**

Pipe Seal Cond: **Sound**
